KETCHIKAN PERFORMING ARTS CENTER

Former Fireside/Elks Lodge Building

Facility Condition Survey and Concept Design Narrative

Submittal Date: June 24, 2009

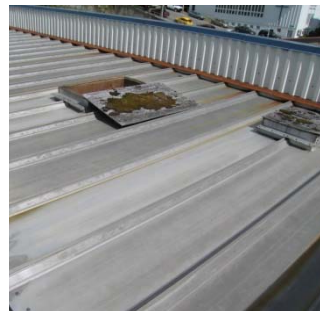
- + Would suggest contacting City of Ketchikan and request replacement of Fire Station top of furnace flue, cap flashing and top cap. Stack gases from this flue settle on Fireside building roof, and with rain create a chemical reaction which has completely corroded the roof galvanizing at the southwest corner of the Fireside roof. Sooner rather than later this section of roof will begin to fail.

Fig.2 Corrosion of roof metal caused by fire station stack gases

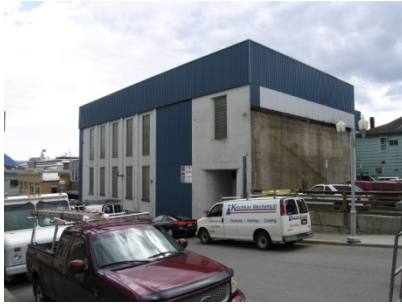
Fig.5 Street view from Northeast

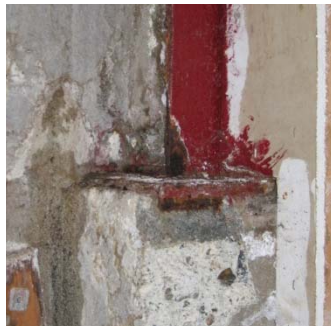
Fig.10 Corroded column base

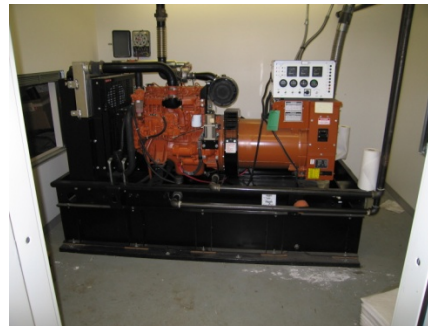
Fig.11 Backup generator for First Bank

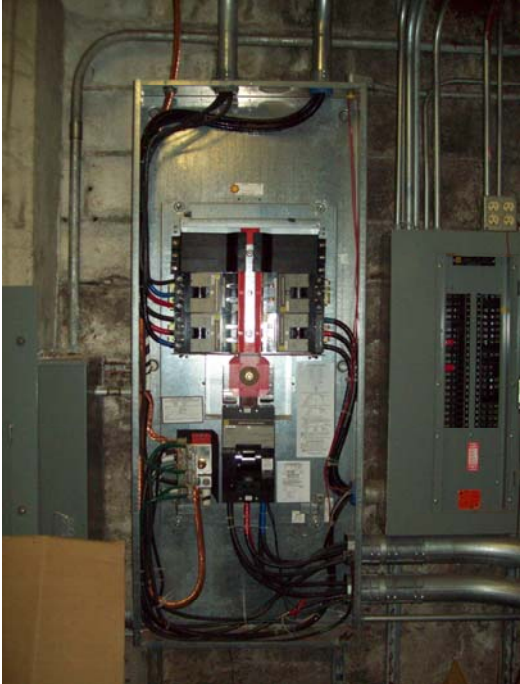
The 400A, 208V, 3-phase, 4W main distribution panel is in excellent condition and can be reused but the following issues need to be considered before any future renovations.

Fig13. Existing 400A, 208V, 3-phase MDP in Excellent Condition

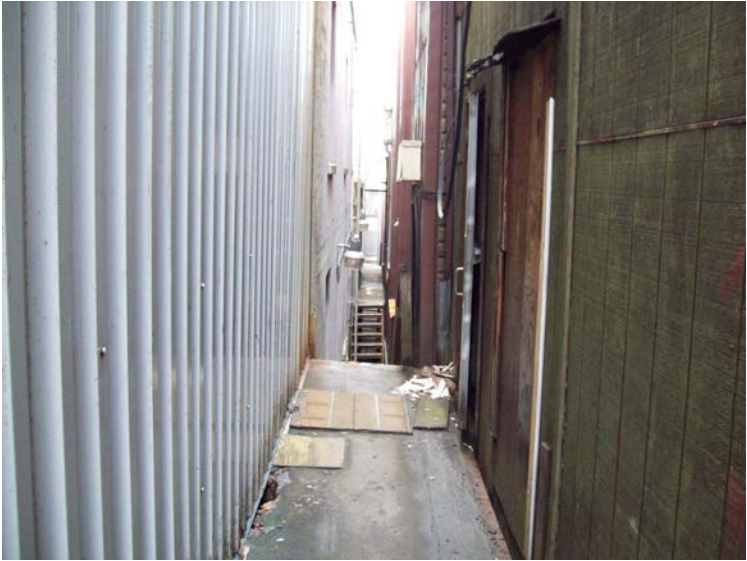
Fig.14: Alleyway to First Bank Building on Dock St.

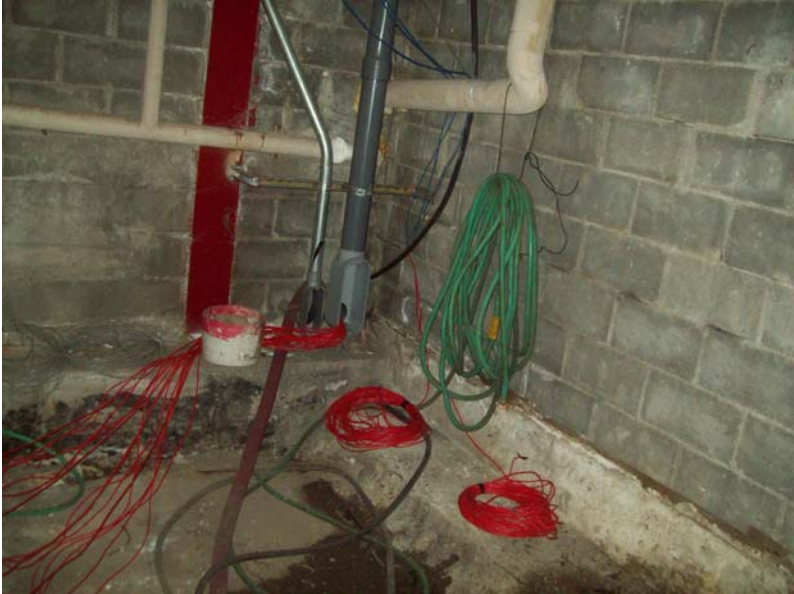
3. The 200A,208/120V,3-phase outside feeder from the main distribution panel in the Fireside Building at 335 Main Street to the First Bank Building on Dock Street cannot remain after the building changes ownership per NEC 225.30. An outside feeder to a separate building is only allowed with public utility and AHJ approval when all the buildings are under the same management and on the same property.

Fig.15. Electrical and Telecom Feeds to First Bank on Dock St.

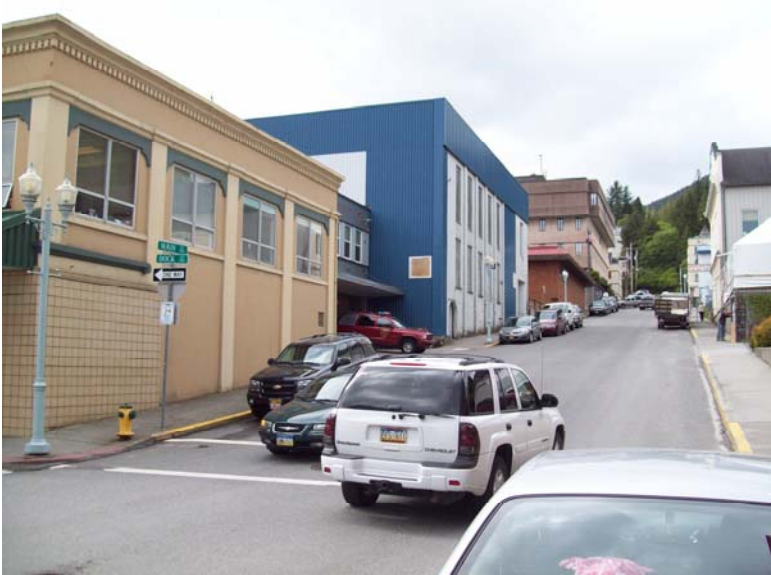
Fig.16: First Bank in foreground and Fireside Building in Background

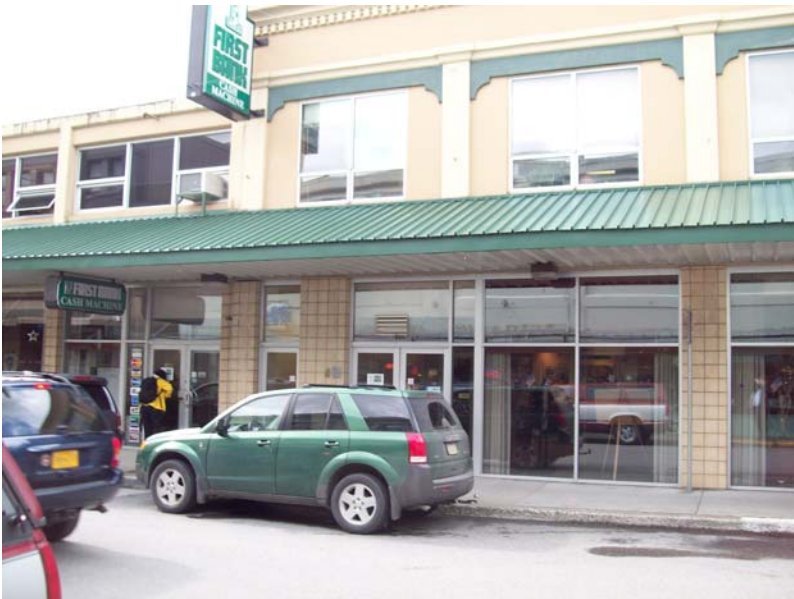
Fig.17: First Bank, Dock Street Data Center on the second floor.

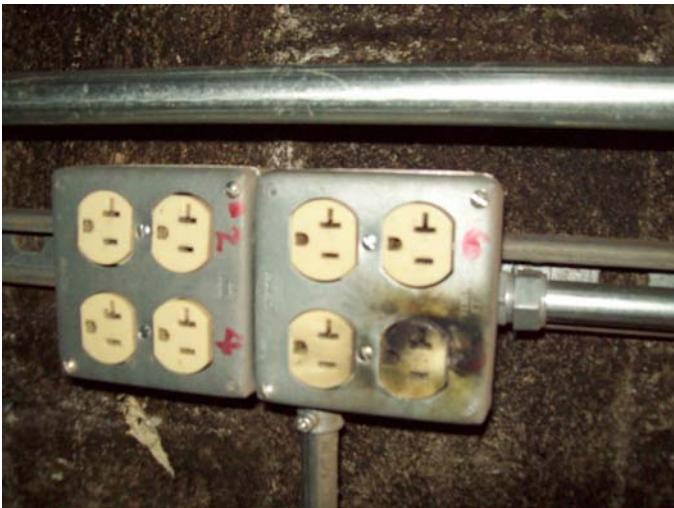
Most of the electrical switches and receptacles in the building are in fair to poor condition and should be replaced during future building renovations. Richard Childs the First Bank Maintenance Manager mentioned that the shop receptacles may be salvaged for the carpentry shop equipment. Any unused branch circuit wiring should be demolished back to the electrical panel and associated breakers marked as spares. None of the existing electrical devices or branch circuits should be considered useable in any future renovations and a new wiring system for the entire building needs to be considered in any future renovations. Only devices, conduit and branch circuit wiring deemed serviceable after careful inspection from a licensed electrician should be reused in future renovations.

Fig18. Receptacles in Poor Condition

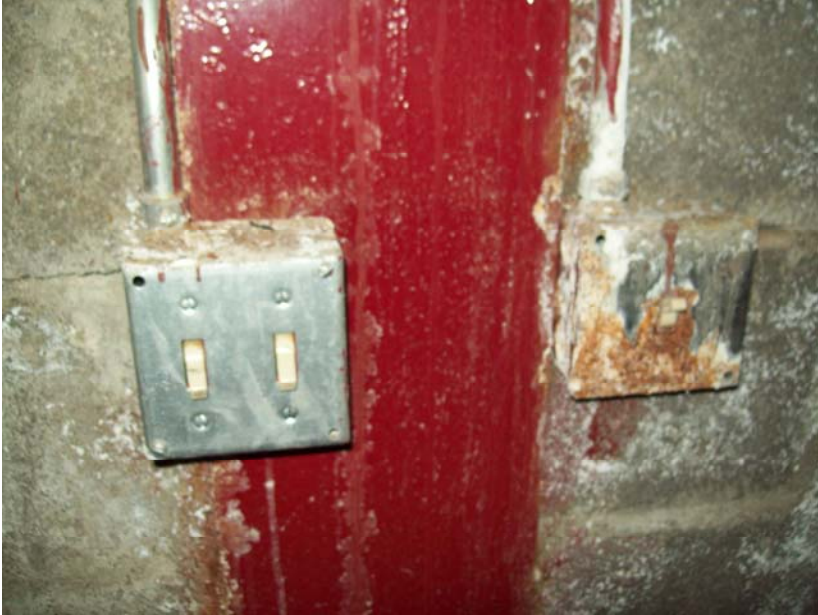
Fig.19: Light Switches in Poor Condition
